**SN 215  
SN 162/32-021  
Main Landing Gear Leg Fitting Lugs Detail Inspection**

# SERVICE NEWS

**SUBJECT:** Main Landing Gear Leg Fitting Lugs Detail Inspection

**MODELS AFFECTED:** All MU-2B Long Body Aircraft

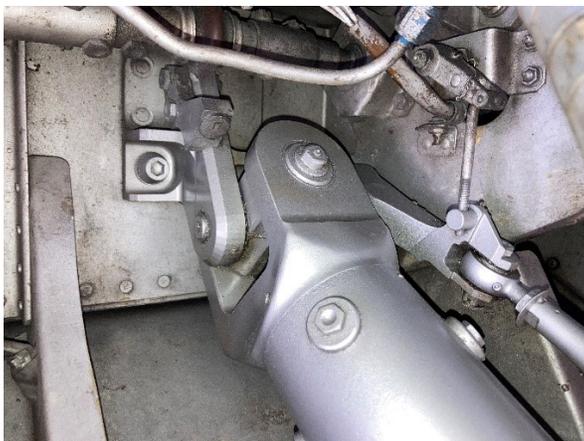
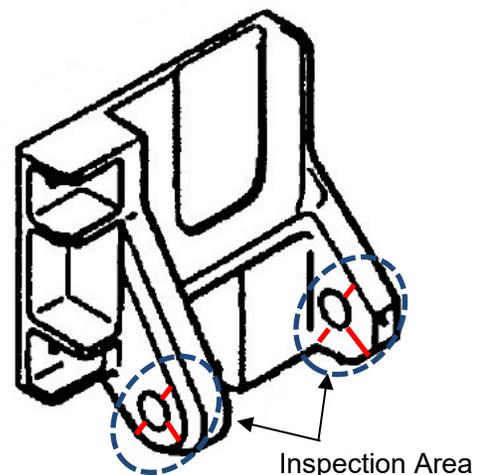
Figure 1: LH MLG Leg Fitting (P/N 030A-32315-1)

Mitsubishi Heavy Industries, Ltd. (MHI) issued Service News No. 211 (JCAB / A2PC) and No. 160/32-020 (FAA / A10SW), dated July 1, 2024, encouraging visual inspection of main landing gear (MLG) leg fittings, P/N 030A-32315-1/-2, on long body aircraft during periodic inspections. Since the release of the Service News, MHI has received additional reports of cracked fitting lugs found during routine inspections. Substantial damage to the fuselage can result from failure of fitting lugs during normal operations.

While a non-destructive inspection method is being prepared, MHI requests that each long body airplane owner and/or operator perform a detailed visual inspect and a dye penetrant inspection for any cracks in or around the lug portion of the fittings before the next flight and during the next periodic inspection. Areas to be inspected are indicated in Figure 1 below. Additional potential crack locations are highlighted. Also, it is important to apply lubrication to the fittings through grease ports in accordance with instructions in the applicable Maintenance Manuals.
