SUBJECT: Hartzell Propeller Alert Service Bulletin HC-ASB-61-413

MODELS AFFECTED: All MU-2B Airplanes with Hartzell Scimitar Propeller Assemblies

HARTZELL PROPELLER LLC
ALERT SERVICE BULLETIN
HC-ASB-61-413
Hub Inspection

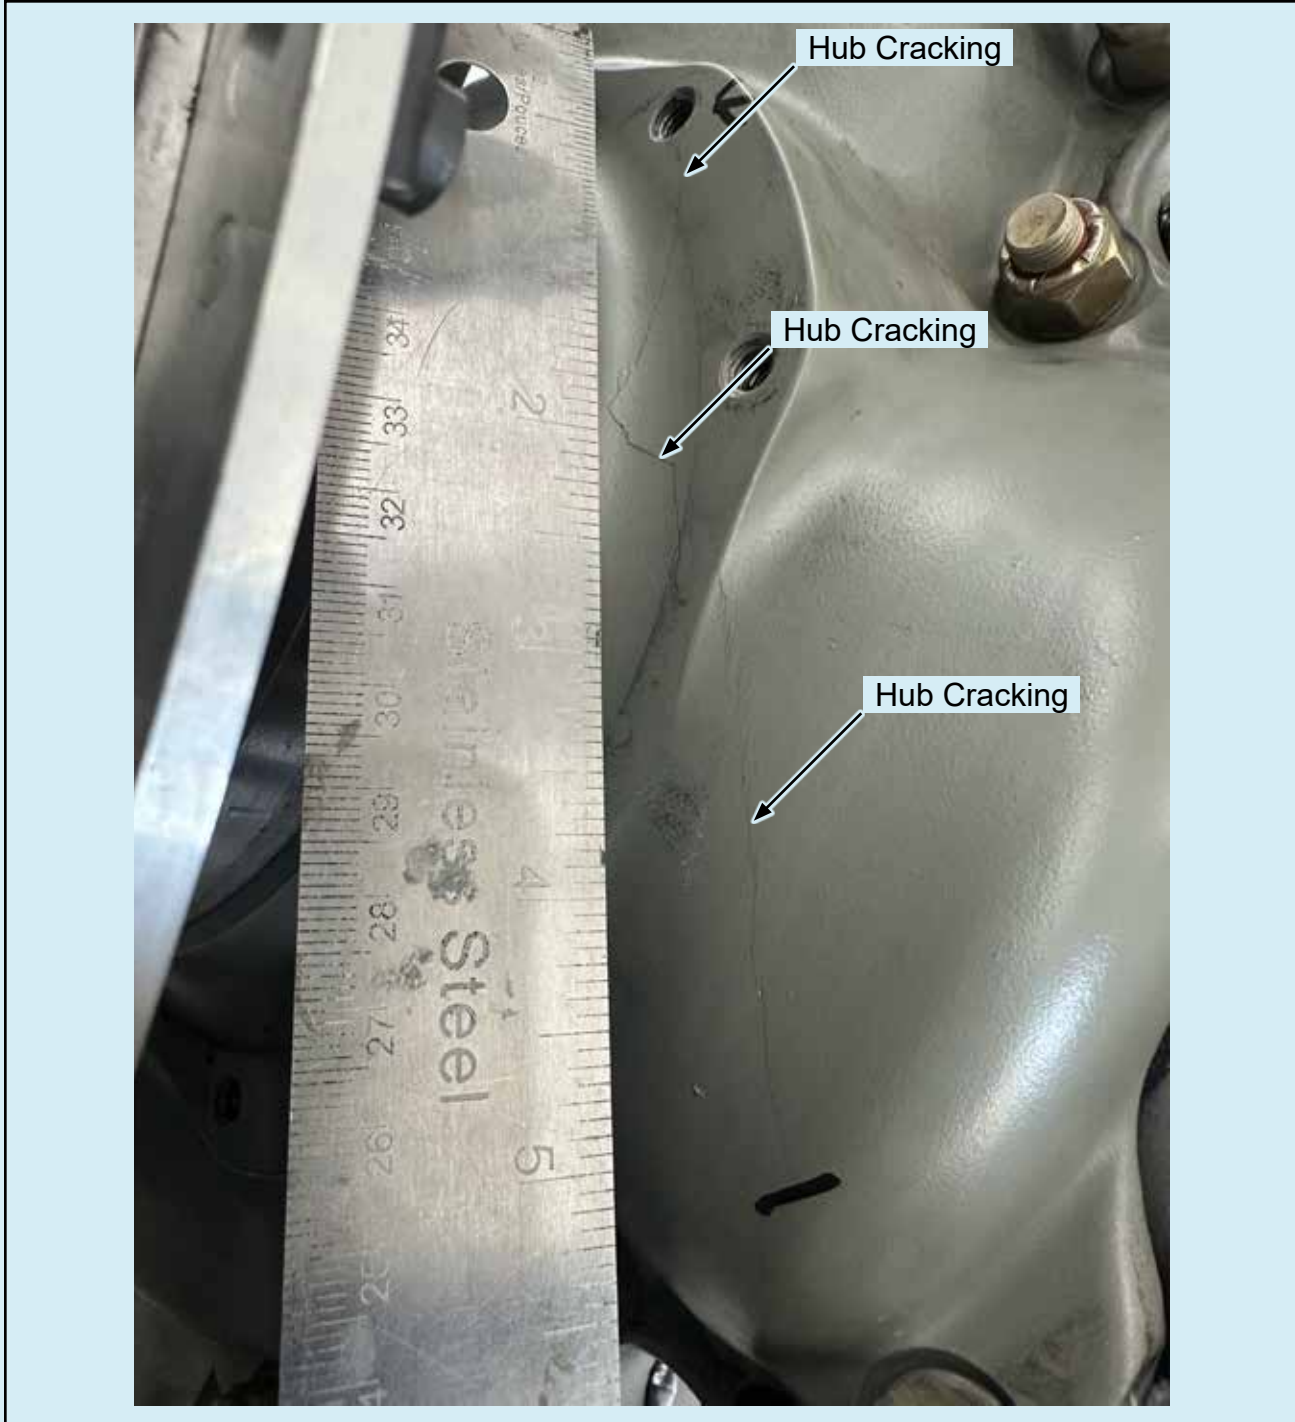
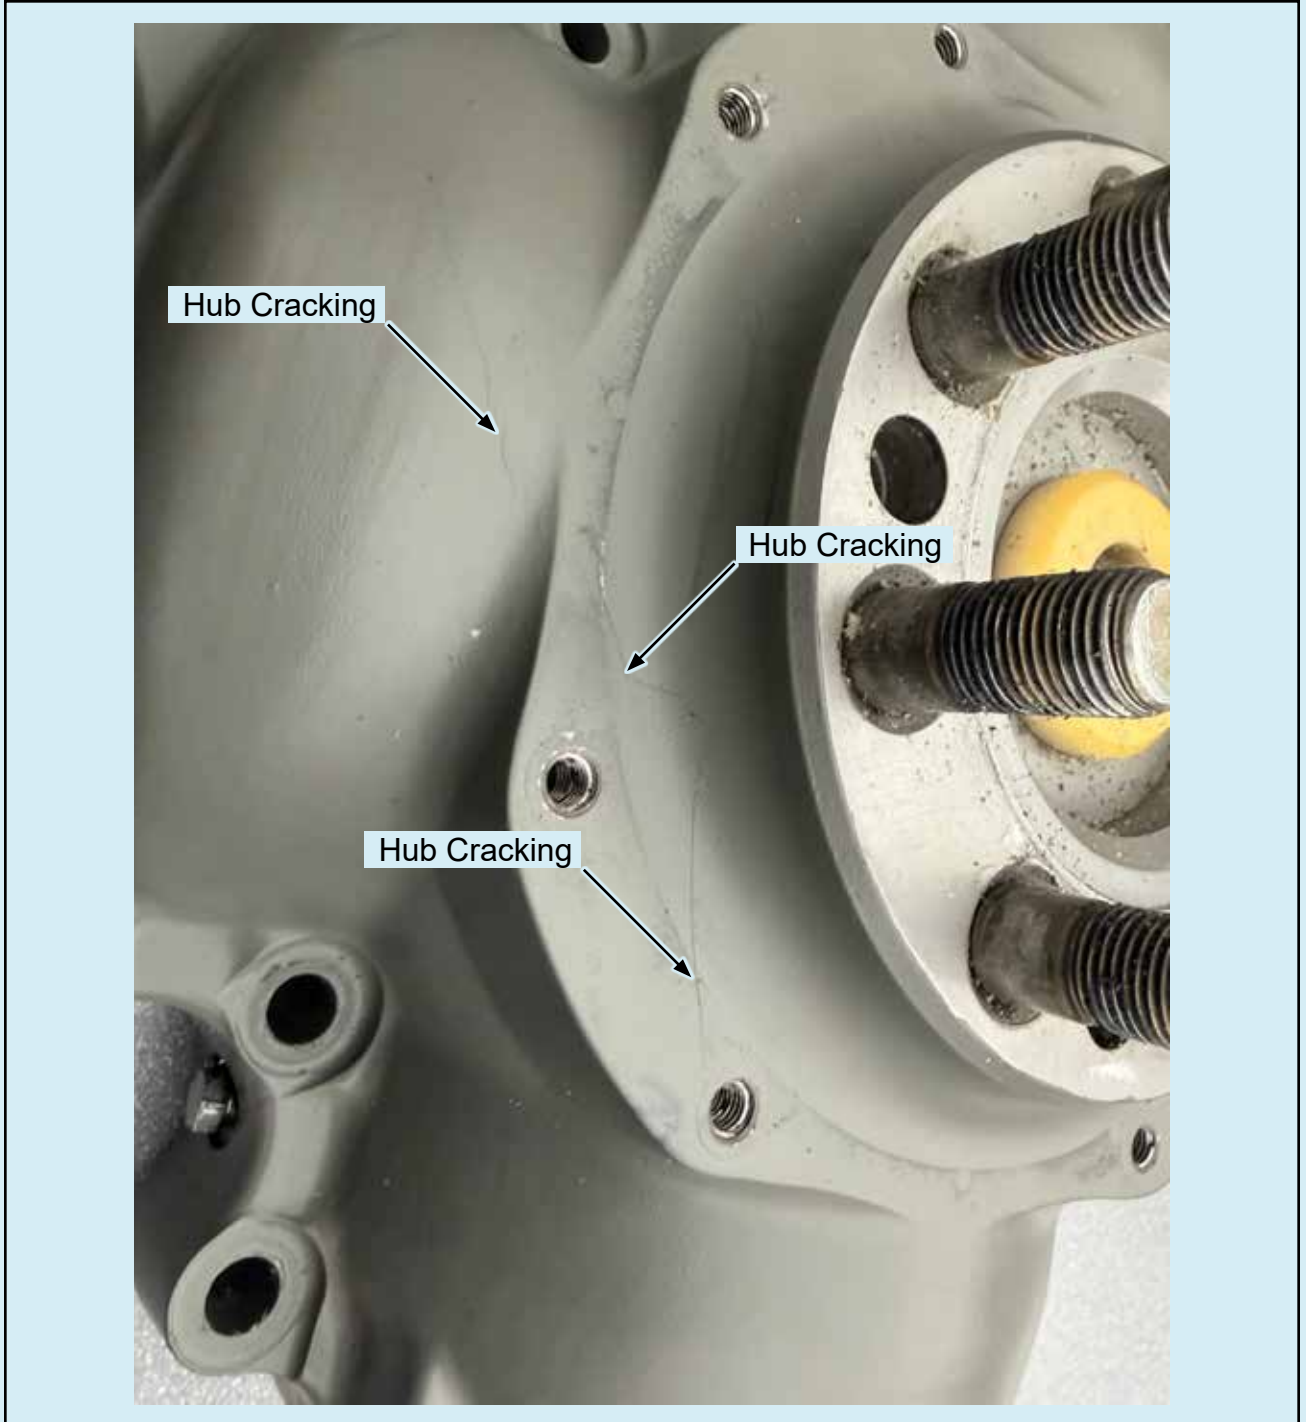
- (1) Hartzell Propeller received a report of hub cracks on an affected propeller. Refer to Figure 1.
 - (a) The propeller reporting the cracked hub had accumulated approximately 3300 flight hours.

Hub Cracks
Figure 1, page 1 of 2

Hub Cracks
Figure 1, page 2 of 2

- (1) Remove the spinner dome in accordance with the applicable Hartzell Propeller owner's manual.
- (2) Using a mirror and/or borescope, examine all areas of the hub for cracking, focusing on the flange area and hub arms of the engine-side hub half. Refer to Figure 1.

- (a) Report findings to Hartzell Propeller. If cracking is found, discontinue flight and contact Hartzell Propeller immediately.
- (3) Examine the propeller for excessive blade play and/or grease leaks.
 - (a) Report findings to Hartzell Propeller. If excessive blade play or a grease leak is found, discontinue flight and contact Hartzell Propeller immediately.
- (4) Complete the Inspection Compliance Form in the Appendix section of this Alert Service Bulletin.
- (5) Make an entry in the propeller logbook indicating this inspection was performed in accordance with this Alert Service Bulletin.
